Slope Failure at Dawson Memorial Field

GREEN EARTH MANAGEMENT CO LTD

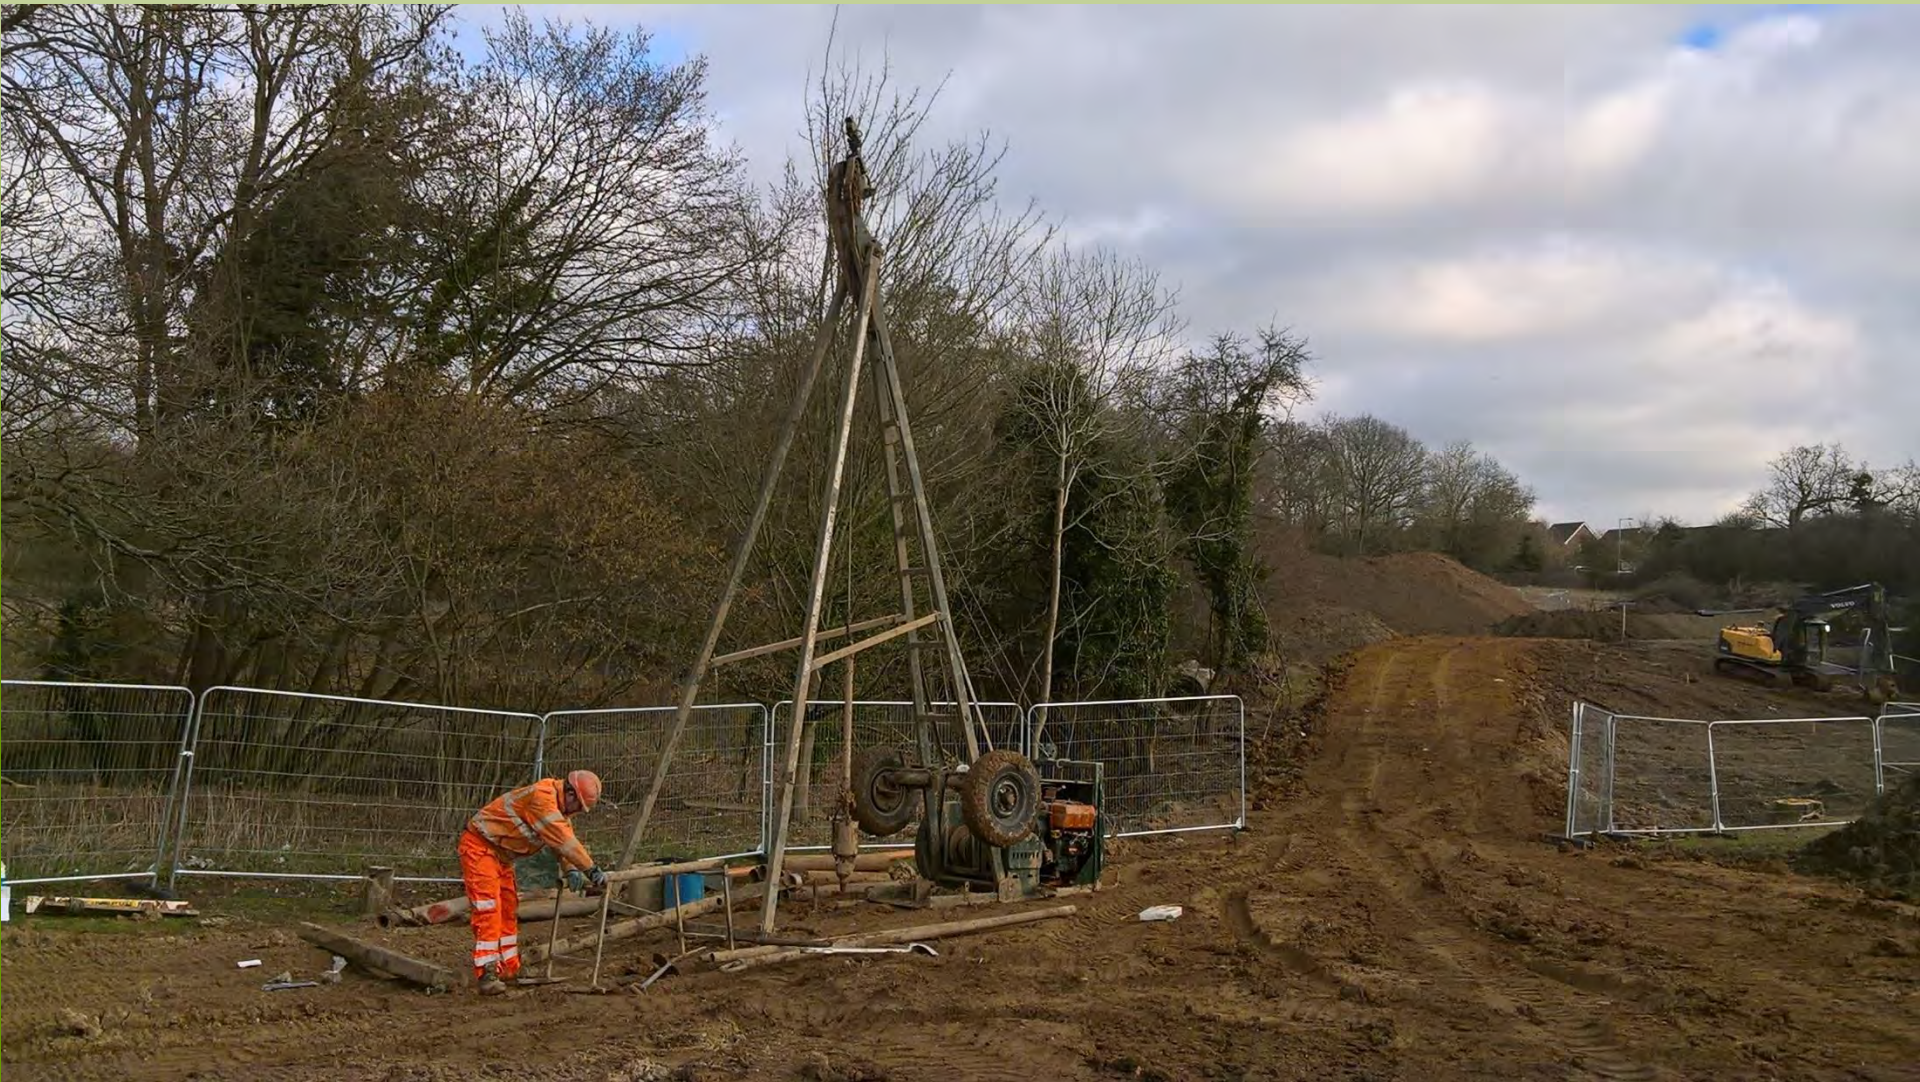
Site Investigation

- Slip Surface- Weight of soil combined with increase in water (e.g. after heavy rainfall) at top of slope pushes slip forward.
- Made Ground from previous works washing down slope.
- Failure Mechanism not fully understood at this stage.

- Re-profile/ re-shape slope (+geogrid mesh)
- Gabions at toe
- Sheet Piles
- Soil Nails or Mechanical Anchors
